# IMPORTANT PRODUCT INFORMATION

**Product: PACSystems™ RX7i CPUs with Firmware Version 1.61**

**IC698CPE010-CD (300 MHz)**

**IC698CPE020-CD (700 MHz)**

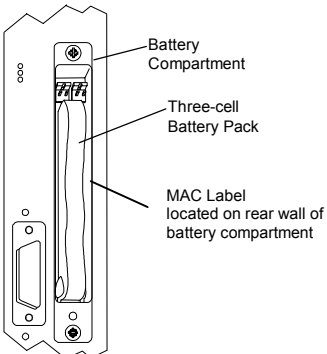
<i>Subject</i>	<i>Description</i>
<b>MAC address</b>	<p data-bbox="743 365 1084 667">A label on the rear wall inside the CPU's battery compartment identifies the MAC address assigned to the CPU's embedded Ethernet Interface. The label is visible when the battery is removed from its compartment. (The battery does not need to be disconnected to temporarily remove it from the compartment.)</p>

<p>The diagram shows a vertical battery compartment. At the top is the 'Battery Compartment' cover. Below it is a 'Three-cell Battery Pack'. On the rear wall of the compartment, there is a 'MAC Label'.</p>
<b>Configuration of IP Address is Required Before Using Ethernet Communications</b>	<p data-bbox="743 730 1455 898">The Ethernet Interface within the CPU module cannot operate on a network until a valid IP address is configured. The necessary Ethernet addressing information must be configured prior to actual network operation, or to recover from inadvertent changes to the Ethernet addressing data at the Ethernet Interface. Use one of the following methods to initially assign an IP address:</p> <ul data-bbox="776 909 1471 1230" style="list-style-type: none"> <li data-bbox="776 909 1455 1020">■ Connect a serial terminal to the Station Manager port of the PACSystems RX7i . Then use the CHSOSW command to enter the desired IP address. For details, see <i>Station Manager for the PACSystems RX7i</i>, GFK-2225.</li> <li data-bbox="776 1031 1471 1110">■ Temporarily assign an IP address to the module using the SetIP tool over the Ethernet network. For details, see <i>TCP/IP Ethernet Communications the PACSystems</i>, GFK-2224.</li> <li data-bbox="776 1121 1455 1230">■ The Ethernet Interface automatically obtains a temporary IP Address from a BOOTP server on the network. For details, see <i>TCP/IP Ethernet Communications for PACSystems</i>, GFK-2224.</li> </ul> <p data-bbox="743 1241 1455 1375">Once a temporary IP address has been set up, the Ethernet Interface can be accessed over the network (such as by the CIMPLICITY ME programming software). The programmer should then be used to configure the proper IP address for the Ethernet Interface.</p>
